SOARING SAFETY FOUNDATION

**1999
SAFETY
REPORT**

**SOARING SAFETY FOUNDATION
ANNUAL SAFETY REPORT
1999**

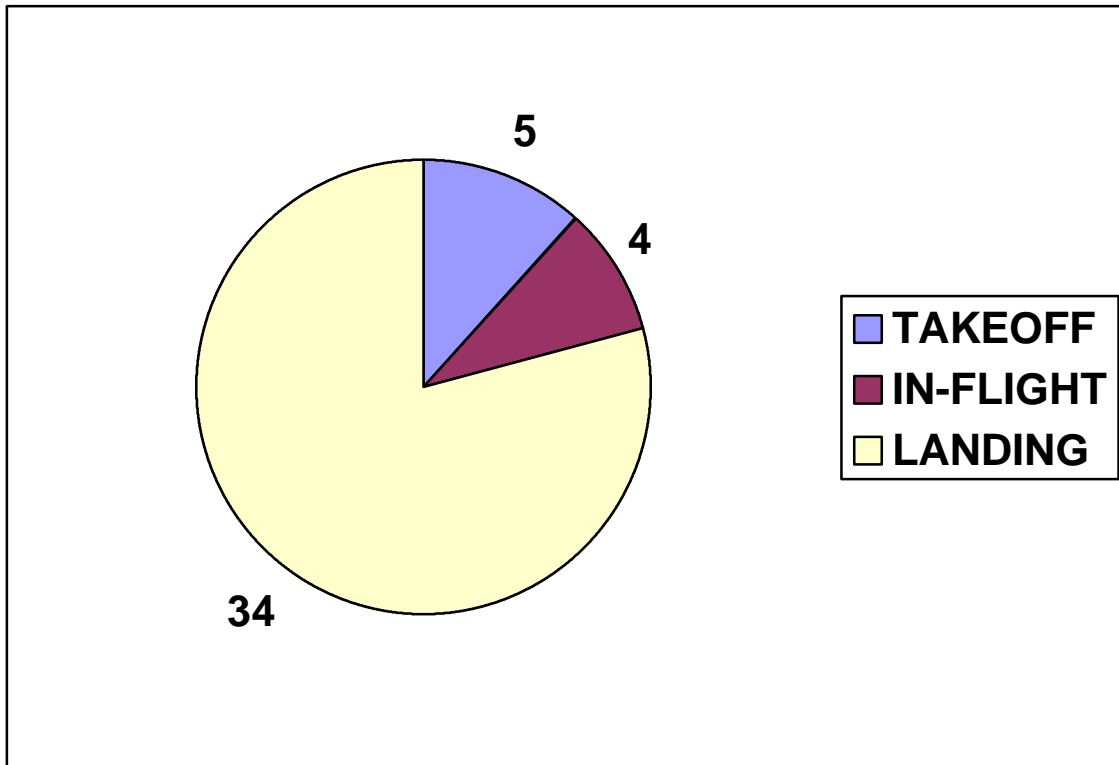
**PHASE OF FLIGHT
1999**

The number of accidents occurring during approach and landing again far surpassed those recorded during any other phase of flight. For 1999, the number of landing accidents was more than three times the combined number of accidents that occurred during the takeoff and in-flight phases. For the year, approximately seventy-nine percent (79%) of the reported accidents occurred during landing. These represents an increase from the sixty-seven percent (67%) reported for the previous year. As has been the case in previous years, takeoff and landing accidents accounted for over ninety percent (90%) of the total number of accidents for the year.

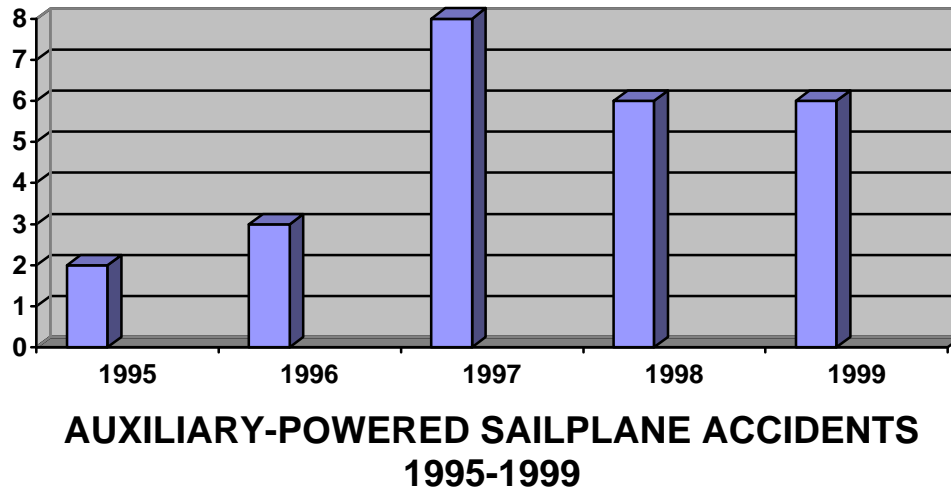
For the twelve-month period ending December 31, 1999, six (6) accidents involving auxiliary powered sailplanes were reported to the National Transportation Safety Board. This represents no change from the number of accidents reported for the previous year.

As a result of these accidents, two pilots were fatally injured and three aircraft destroyed. For the five-year period 1995-1999, auxiliary-powered sailplanes have averaged five (5) accidents per year. This is up slightly from the 4.6 per year average of one year ago.
