SOARING SAFETY FOUNDATION

**1998
SAFETY
REPORT**

SOARING SAFETY FOUNDATION ANNUAL SAFETY REPORT 1998

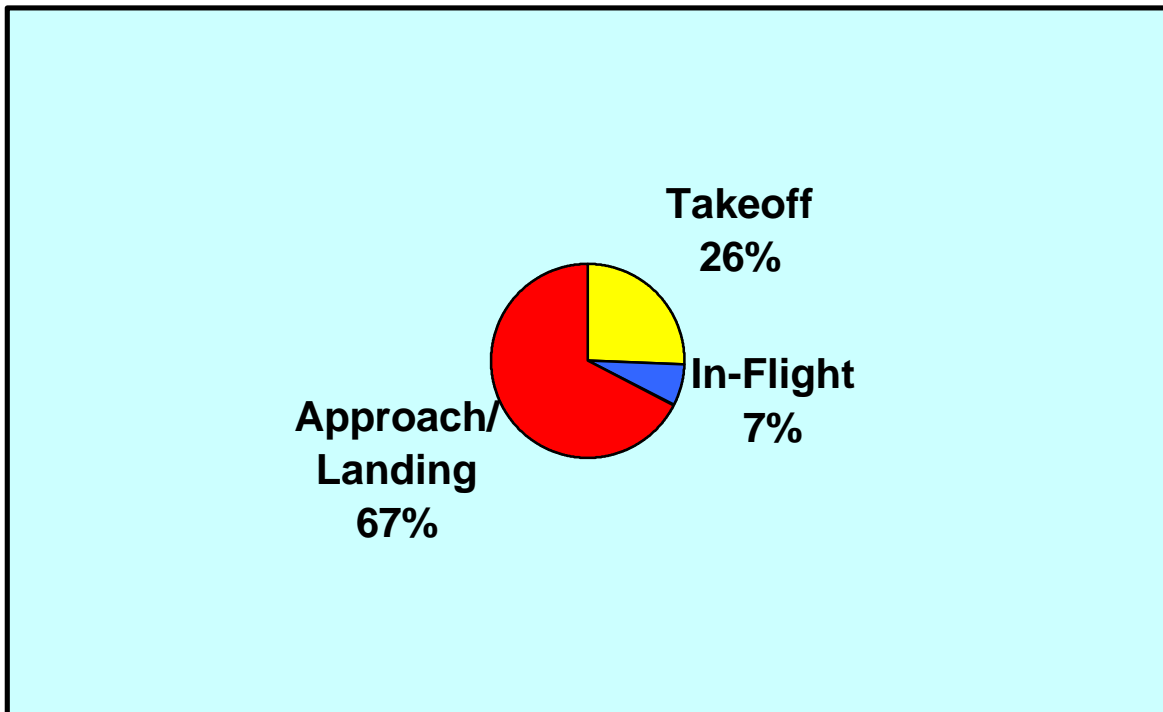
PHASE OF FLIGHT 1998

The number of accidents occurring during the approach and landing again far surpassed those recorded during any other phase of flight. As was the case during the 1997 reporting period, accidents occurring during the approach and landing were more than double the combined total of accidents occurring during any other flight phase. For the year, takeoff and landing accidents attributed to approximately 93% of the number of accidents reported for the year. This percentage represents an increase from the 83% recorded during the 1997 reporting period.

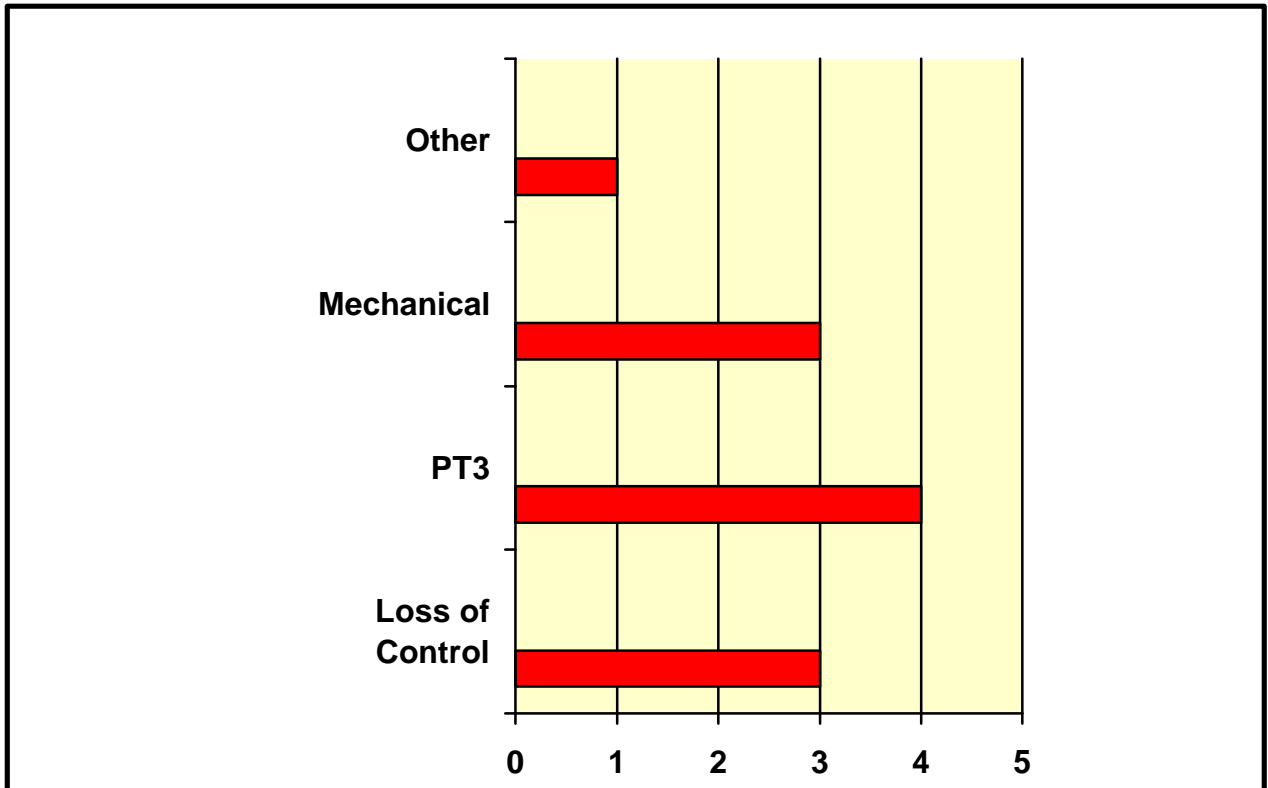
TAKEOFF ACCIDENTS 1998

Mechanical malfunctions accounted for a significant number of takeoff accidents during the 1998 reporting period. These included an L-13 Blanik that sustained substantial damage during a ground launch. During the initial part of the launch, the ground launch bridle disconnected from one attachment point. The asymmetrical force then pulled the glider to the left, and the left wing struck a parked truck.

Problems associated with maintaining directional control also contributed to a number of takeoff accidents. In two of the accidents involving loss of directional control, the gliders struck parked vehicles or other obstructions after leaving the runway. A more serious loss of control accident occurred when the pilot of a SGS 1-35 moved out of position to the right during an aerotow. This movement caused the tow plane to yaw hard to the left. After bringing the glider back to the normal tow position, the glider veered to the right again very rapidly. The tow plane yawed hard to the left and the towline broke at an altitude of approximately 700 feet above ground level. As the pilot attempted to return to the airport to land, the glider impacted a ditch that ran between the two runways.
